Arch Beams Pose A Real Danger To Workers

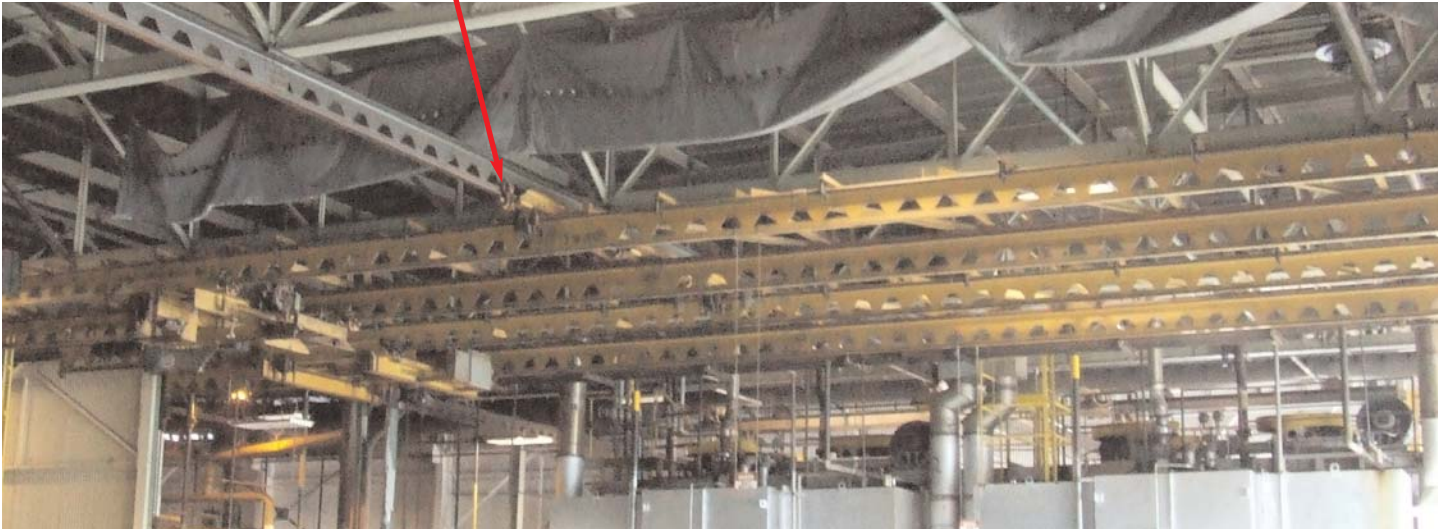
Does your crane look like this?

The welds in Arch Beam can weaken over time and experience Martensitic Failure, resulting in the bottom rail peeling away from the web plate. This safety issue should be brought to the attention of management immediately.

- * Loading Tables in old catalogs were calculated for new beam as built at that time.
- * As of this date (March 2, 1992) all Arch Beam should be replaced with Tarca® due to its age, and De-Rating of capacity is no longer advised.
- * Arch Beam should also be replaced with Tarca® versus ANY repair due to age and many years of fatigue.

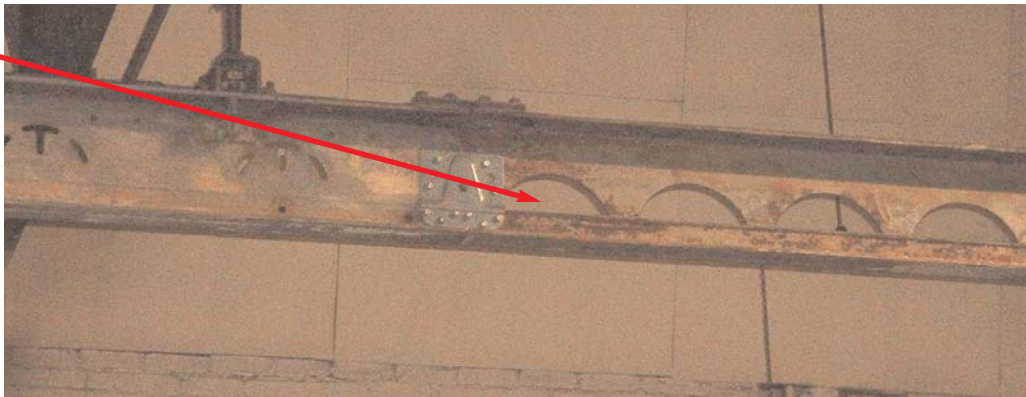
Or this?
